THE SILENCER HANDBOOK

FAULT PREVENTION

*ENSURING LASTING & SAFE OPERATION
OF YOUR SILENCER*

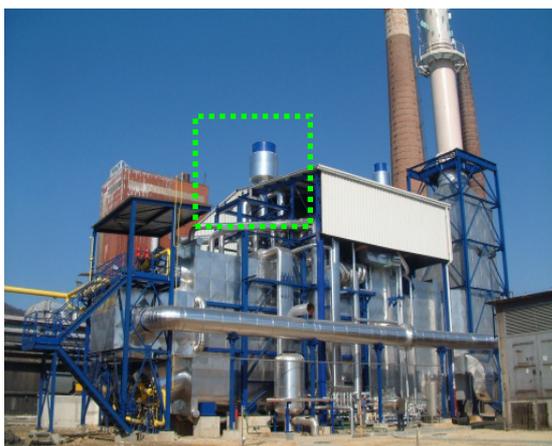
optimal installation of a vent silencer on a roof, ensuring maximum noise reduction and safe operation

- ✓ Vent silencers should be installed at a possibly high location, away from work areas and facades, preferably on a roof.
- ✗ Vent silencers should not be installed near a higher wall, façade or building. Nearby surfaces reflect noise, causing increased sound pressure levels.
- ✗ Vent silencers must never be installed inside a building, or close to regularly used work areas

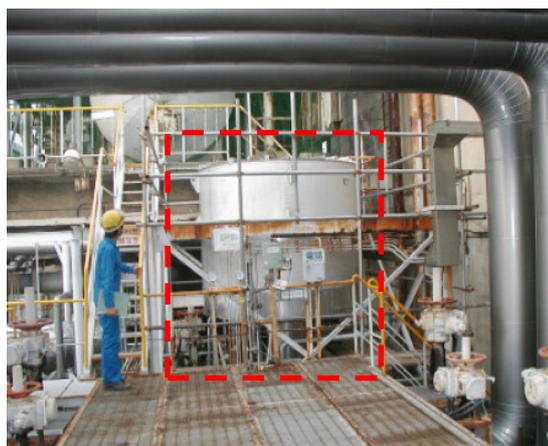
dangerous, potentially lethal installation of a silencer inside a building

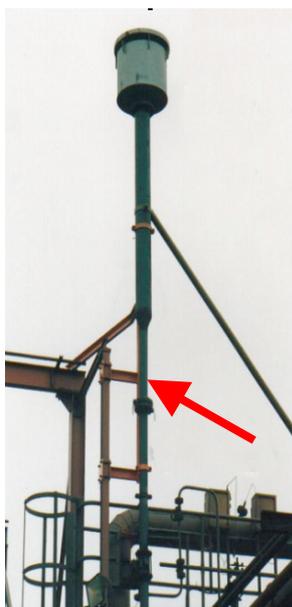
the blow-off pipe is not insulated and too small in diameter in the lower section, causing avoidable noise emissions

To be efficient, these measures have to be implemented comprehensively; it makes little sense to e.g. match the dimension of the blow-off pipe to a valve outlet and increase the diameter only just before the silencer, as shown in the example below. The high blow-off speed in the thinner duct section causes pressure losses in the blow-off pipe, leading to increased sound emissions from the pipe.

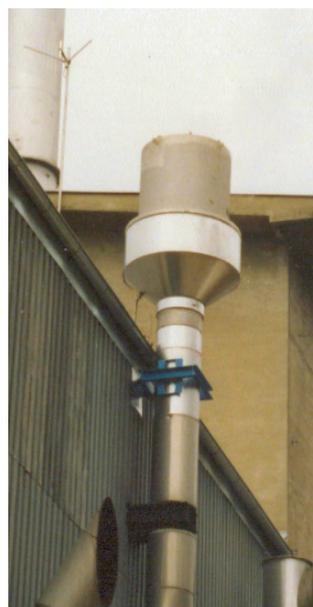
positive example of a properly installed and insulated blow-off pipe and silencer

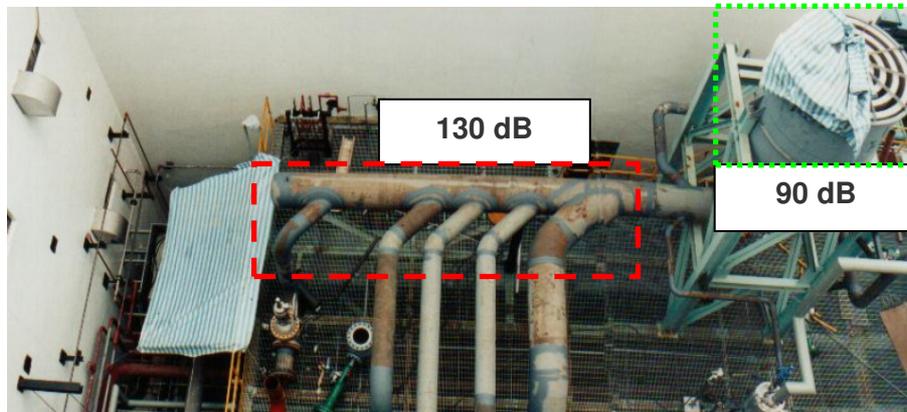
Example of a poorly designed blow-off installation: although the noise of the exhausted gas is efficiently attenuated by a silencer, the non-insulated, bent and branching blow-off pipes cause very high noise emissions.

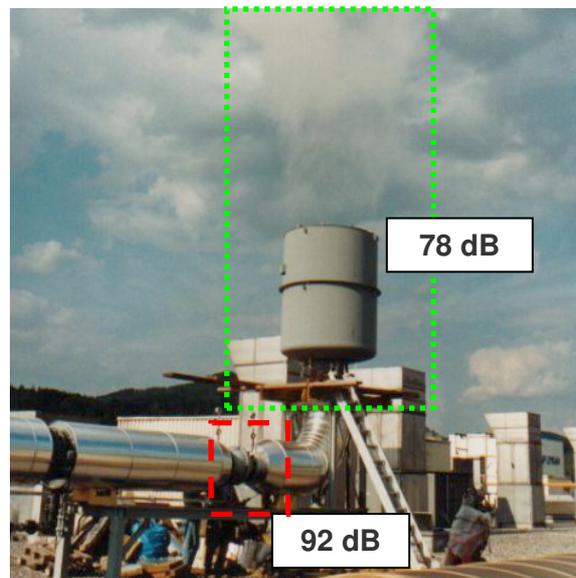
Blow-off installation with improvement potential: while the noise of the effluent gas is successfully muffled by the vent silencer and the blow-off pipe is suitably insulated, the valve is not and thus becomes the dominating source of noise.

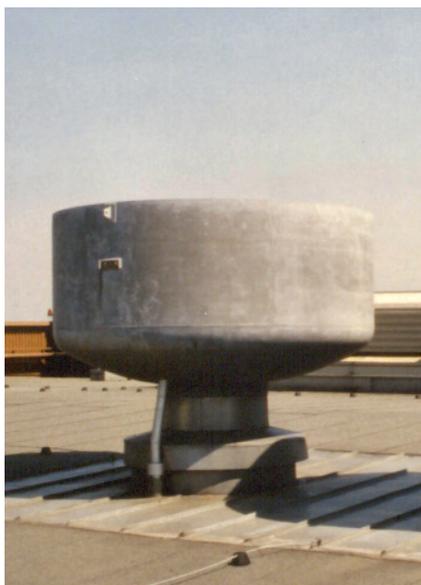
the (non-insulated) dewatering pipe is connected to the drainage by a possibly short pipe, which is kept close to the silencer body

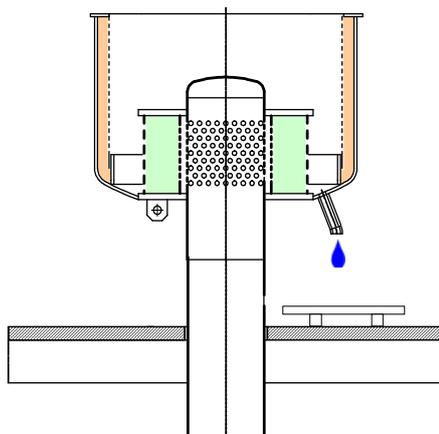
when using an open drain system, a plate or cup beneath the dewatering pipe helps preventing long-term roof damage by (hot) dripping condensate

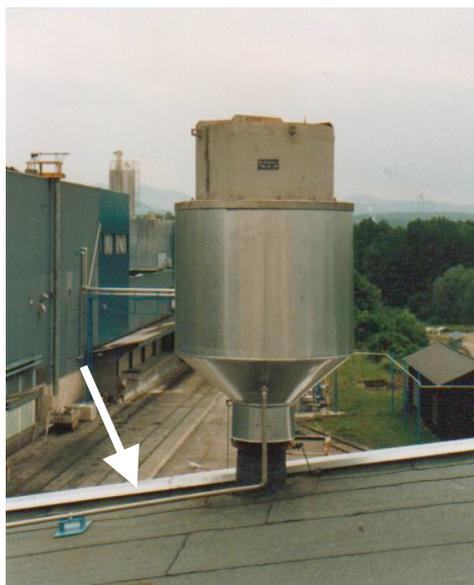
a long, non-insulated drainage pipe is prone to freezing at sub-zero temperatures, thus preventing dewatering of the silencer

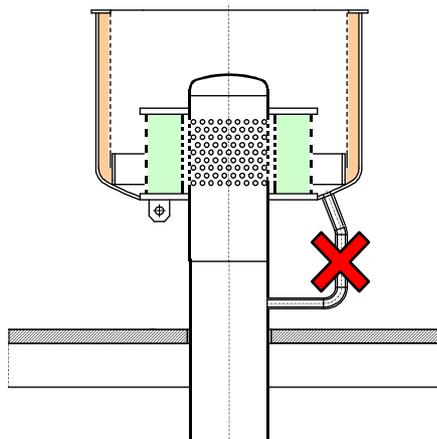
the drain must never by-pass the diffuser, as this would significantly reduce the noise reduction efficiency of the silencer and may damage the entire installation

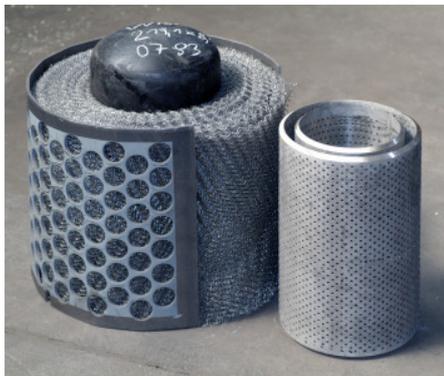
... uses seamless diffuser pipes, wrapped with high quality stainless-steel wire mesh to reduce swirls

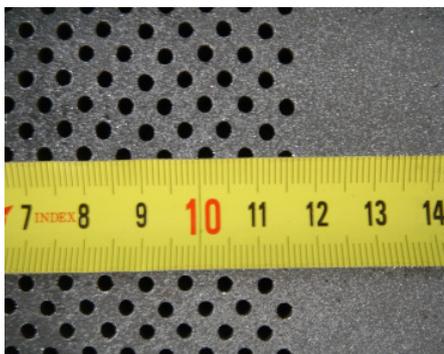
... uses customised designs with small borings, achieving a better noise reduction and shifting the peak frequency to values that can be more efficiently attenuated

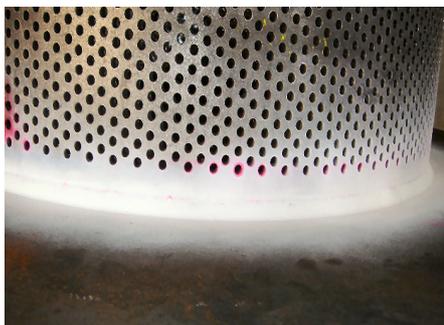
... quality tests all compression-loaded welds, ensuring operational safety

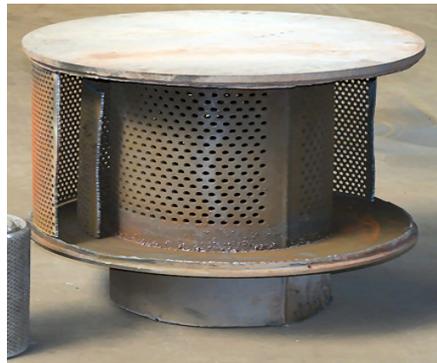
... use just perforated plates as diffuser; in addition to a larger size, the absence of wire mesh causes flow noise emissions

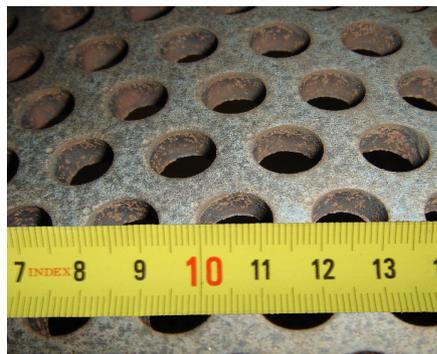
... use standard perforated die plates with significantly larger diameters, resulting in inferior noise reduction and hard-to-attenuate low-frequency emissions

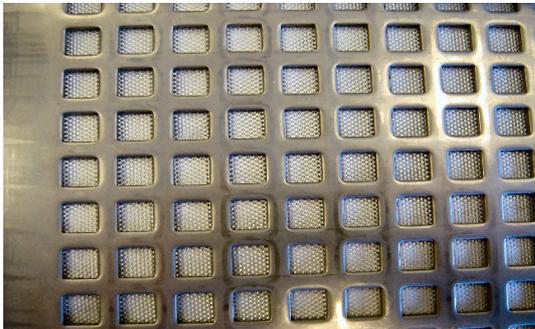
... uses strong, heat resistant glass fabric linings that cover the absorbing materials

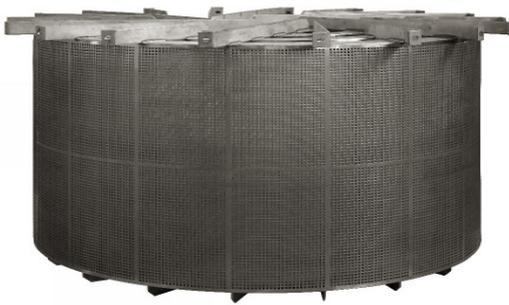
... uses absorbers structures made entirely from stainless steel

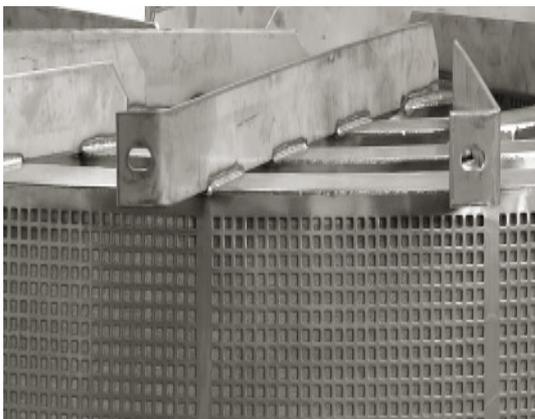
... uses continuous welding on all parts, warranting long service life

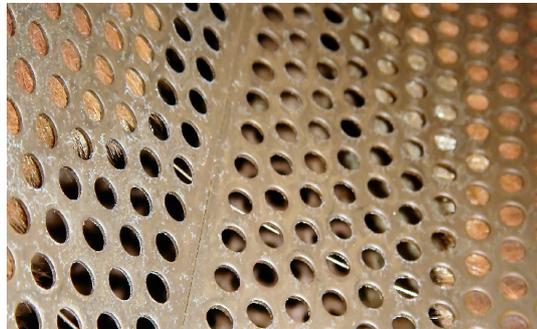
... use cheaper fleece materials that start getting blown out after a few blow-off events

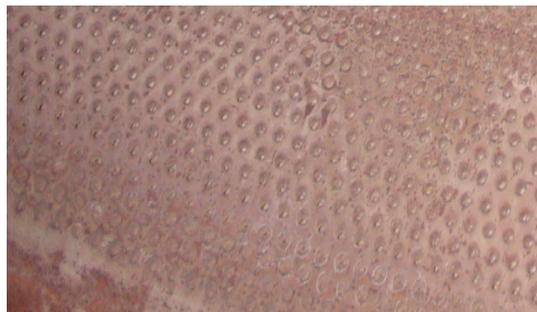
... use carbon steel elements that will corrode quickly under application conditions

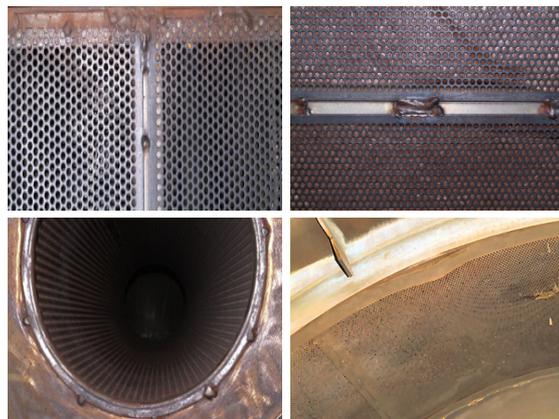
... use standard spot welding, resulting in (noisy) vibrations and early fatigue

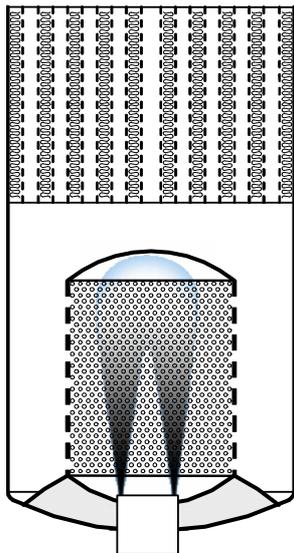
The following example shows the consequences of using a less-than-optimal design in an industrial steam silencer. In the original layout, the steam jet hit the head of the diffuser with sonic speed and high temperature. This not only destroyed the diffuser, but also the absorber core suspensions, blowing the massive absorber stage out of the silencer shell:

original silencer layout

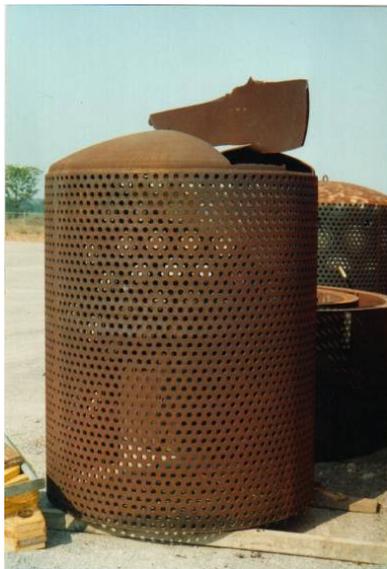
destroyed diffuser

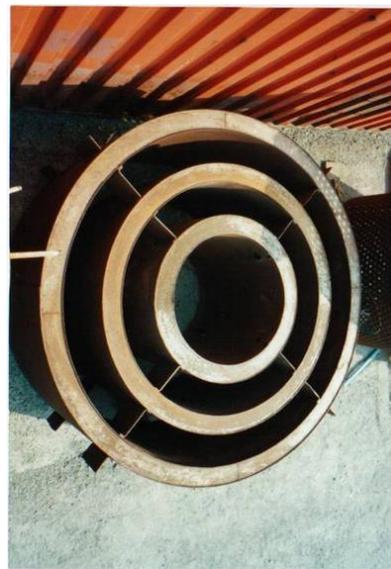
blown-out absorber stage

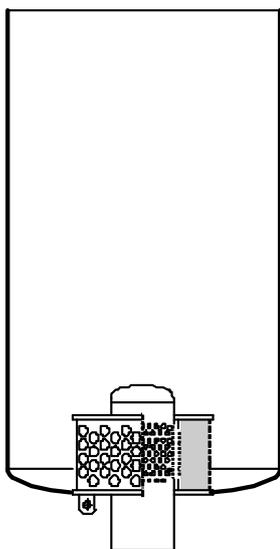
The diffuser cage and the absorber were removed and replaced with a GLAUNACH diffuser. Now, the steam vent silencer works efficiently and reliably without any trouble:

*silencer repair design by
GLAUNACH*

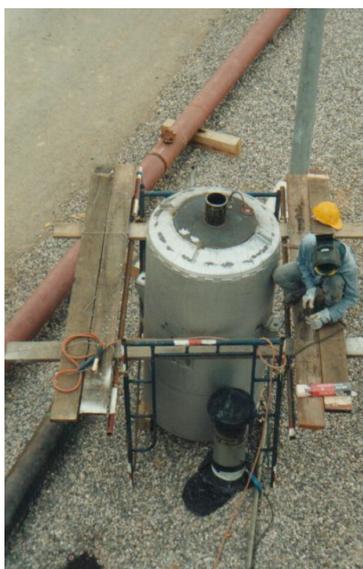
diffuser replacement

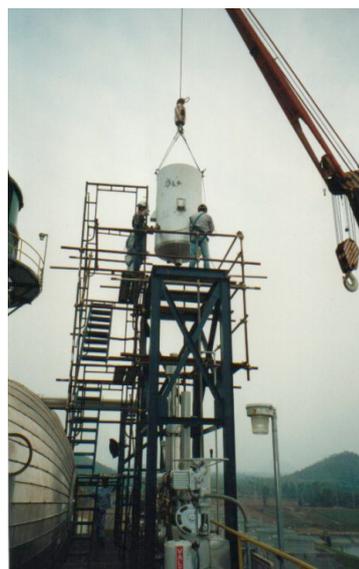
*installation of the repaired
silencer*

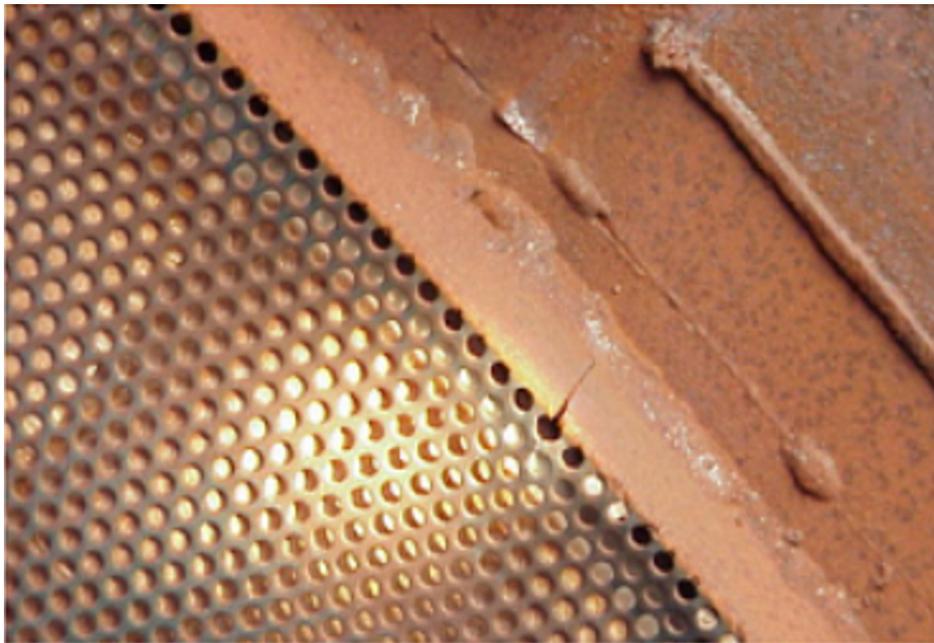
A second example of a catastrophic failure caused by cost saving design is shown below. A poorly welded seam and corrosion led to material failure:

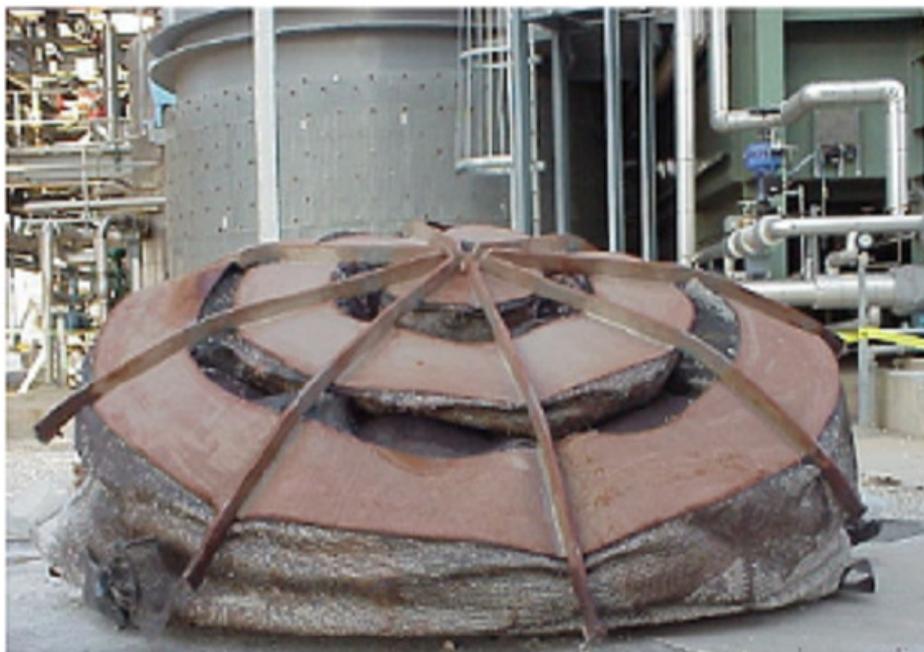
As a direct consequence, the entire massive absorber stage blew out of the silencer and hit the ground ...
